**REPUBLIC OF KENYA
MINISTRY OF DEFENCE**

11 April 2025

**A SUMMARY OF THE REPORT ON BELL UH-1H-II (HUEY) HELICOPTER KAF 1501
CRASH AT SINDAR VILLAGE, KABEN SUB LOCATION, KABEN LOCATION, TOT
DIVISION, ELGEYO MARAKWET COUNTY ON 18 APRIL 2024**

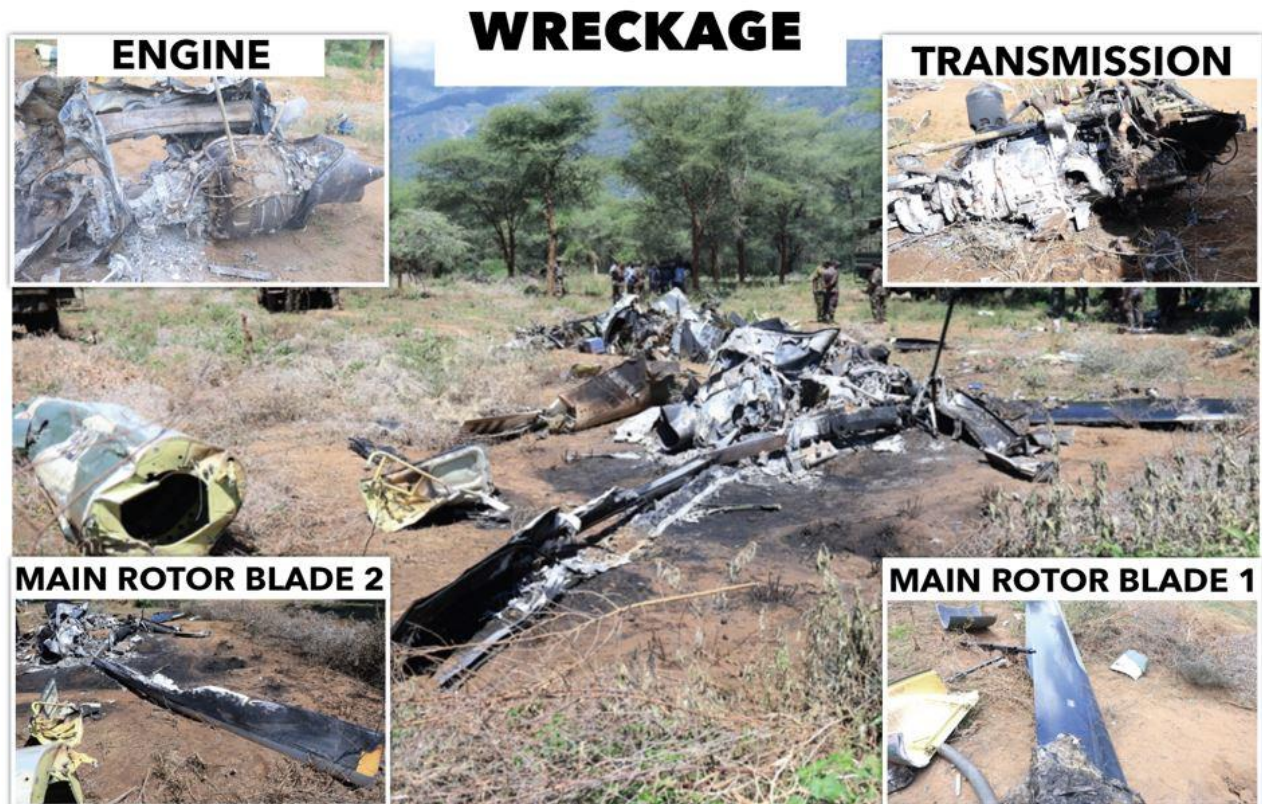
4. At around 1420hrs the Huey KAF 1501; shortly after departure from Cheptulel Boys High School, crashed on a community farm, ‘Shamba la Amani’, and caught fire on impact. The crash at Grid N 01° 17’ 49” E 035° 38’ 21”, 1.3 Nautical Miles East of Cheptulel Boys High School. Area residents together with KDF Personnel from the close by Samu Forward Operating Base (FOB), evacuated the passengers on board and extinguished the fire. Four (4) survivors of the crash were airlifted by Hughes MD 500 Helicopters to Endo Health Centre. Regrettably, two (2) among them succumbed to their injuries and the other two (2) were later on air lifted to Eldoret Regional Hospital (ERH). The ten (10) bodies were later flown to Nairobi.
5. The Helicopter suffered Category Five (Cat 5) Damage (Beyond Economic Repair).
